ATTACHMENT TO L-4878
26 FEBRUARY 1968
PAGE 1PT-76 AMPHIBIOUS TANKS
LANG VEI, SOUTH VIETNAM
1635N 10640E1. SIGNIFICANCE:

PT-76 AMPHIBIOUS TANKS
LANG VEI, SOUTH VIETNAM
16-35N 106-40E

NPIC 1-4878 (2/68)

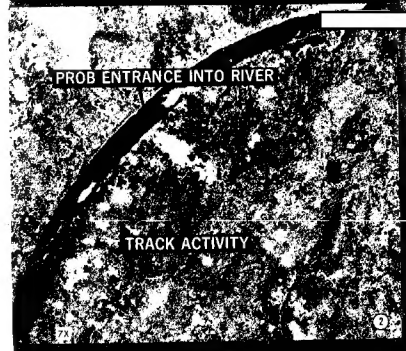
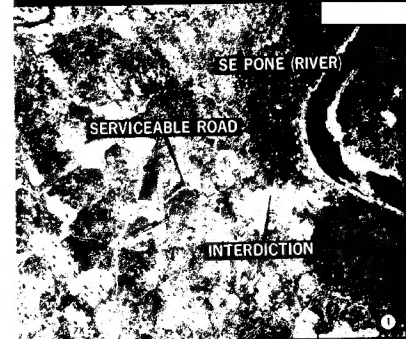
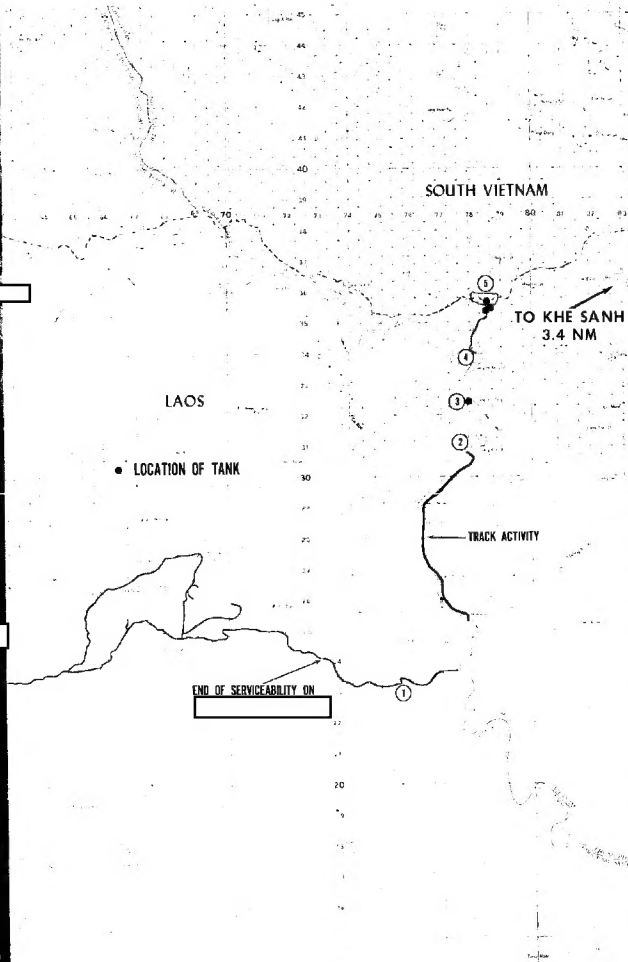
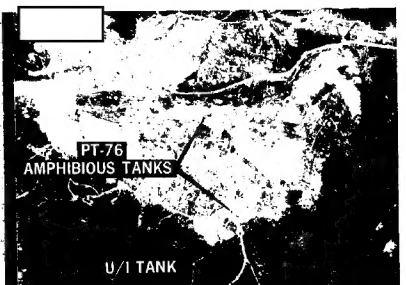
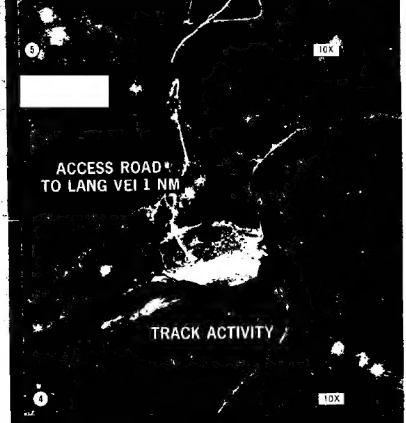
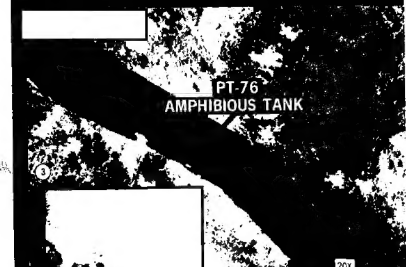
THIS BRIEFING BOARD DEPICTS THREE PT-76 AMPHIBIOUS TANKS AND ONE UNIDENTIFIED TANK IN AND AROUND THE OVERRUN LANG VEI IRREGULAR DEFENSE CORPS CAMP. THIS BOARD ALSO DEPICTS THE LAND AND WATER ROUTE PROBABLY FOLLOWED BY THESE VEHICLES FROM LAOS.

[REDACTED] REVEALS
THE PREVIOUSLY REPORTED (SEE NPIC BRIEFING BOARD L-4791) ROAD UNDER CONSTRUCTION FROM ROUTE 92 AT 162952N 1062931E (UTM XD591244) TO BE SERVICEABLE BEYOND THE PREVIOUS TERMINUS AT UTM XD721244 TO THE LAOS/SOUTH VIETNAM BORDER ON THE WEST BANK OF THE SE PONE (RIVER) AT 162922N 1063948E (UTM XD775236). NO EVIDENCE OF A RIVER CROSSING AT THIS POINT WAS NOTED.

HOWEVER, TRACK ACTIVITY AT THIS POINT INDICATES THAT VEHICLES USED THE RIVER NORTH FROM THIS POINT TO UTM XD778253 WHERE THEY LEFT THE RIVER AND FOLLOWED THE ALIGNMENT OF AN OLD TRAIL FROM WHENCE THEY REENTERED THE RIVER AT UTM XD778308. THE VEHICLES THEN MOVED BEYOND UTM XD779324, WHERE ONE PT-76 IS OBSERVED IN THE RIVER (SEE INSET, [REDACTED] 25X1 WHICH PROVIDES ADDITIONAL, LARGER SCALE PHOTO COVERAGE), AND ON TO THE NORTH BANK OF THE RIVER AT 163458N 1064012E (UTM XD781340). THIS LATTER POINT IS CONNECTED WITH THE LANG VEI CAMP BY A PREVIOUSLY EXISTING, HEAVILY USED SERVICE ROAD ONE NM LONG. OBSERVED ON THIS SERVICE ROAD AT UTM XD785353 IS ONE DAMAGED/DESTROYED PT-76 TANK AND ONE PROBABLY DISABLED, UNIDENTIFIED TANK (THE CHASSIS APPEARS TO HAVE A DIFFERENT CONFIGURATION FROM THAT OF A PT-76 BUT THE POOR QUALITY OF THE PHOTOGRAPHY PRECLUDES A DEFINITE IDENTIFICATION). ONE DAMAGED/DESTROYED PT-76 IS OBSERVED WITHIN THE CAMP COMPOUND.
